## Keeping Up With Research 122

## Riparian Forests Protect Streambanks

Wayne A. Geyer

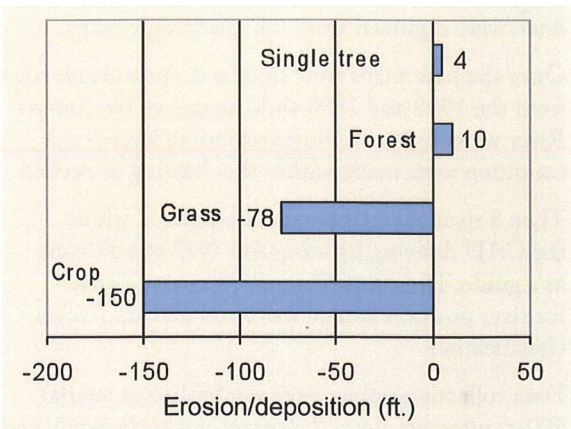
**Figure 2. Lateral movement of streambank by land-cover type.**

Land-cover vegetation significantly ( $P < 0.01$ ) affected the amount of lateral streambank erosion (Figure 2). Both forest and single tree-row vegetation types collected soil, with mean depositions of 10 and 4 ft, respectively, which were not significantly different. Grassland lost an average of 78 ft, and cropland lost an average of 150 ft. Surface acreage of the lost land was evaluated for each mile of stream erosion: 9.4 acres for grassland and 18.2 acres for cultivated land. The latter is equivalent to about a quarter section of land for every 10 miles of stream distance in this study.

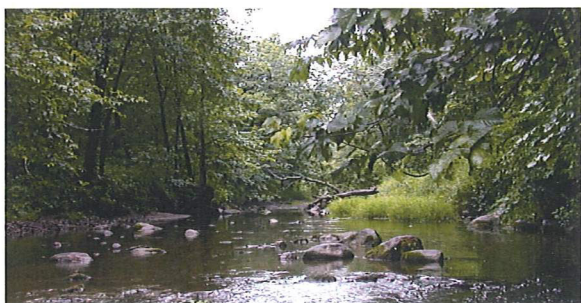
**Figure 3. Natural woody vegetation should be left to protect streambanks.**

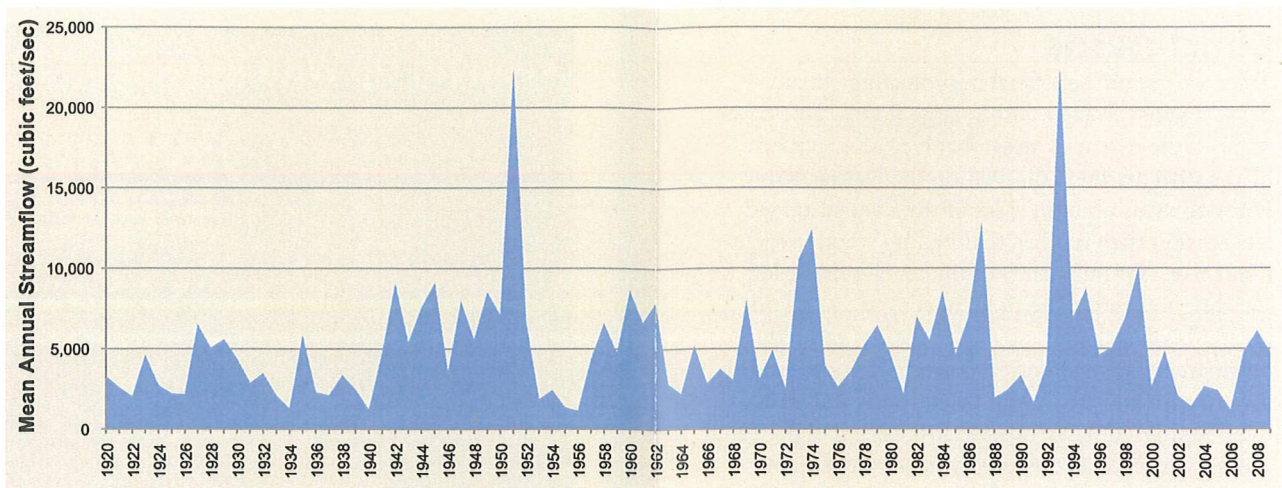
Figure 1. Historical mean discharge of the Kansas River at the beginning point of the study area (Wamego, Kan.).

Variation of stream discharge appears to occur in about 15- to 20-year cycles. The flood of 1993 (500 year) was of historic proportions, but a similar flow occurred in the early 1950s. Streamflow in central Kansas in 1950 and 1993 was 4.5 times the historical yearly averages (Figure 1). Because of this variation, streambank losses usually are not recognized until a major high-water event happens.
